IMO - 89A

INSTALLATION, MAINTENANCE, AND OPERATING INSTRUCTIONS

BODY STEAM JACKET CONVERSION FROM 4" (DN 100) AZFRC TO 4" (DN 100) SUZRC TANK CAR FIRE-TITE® BOTTOM UNLOADING VALVE

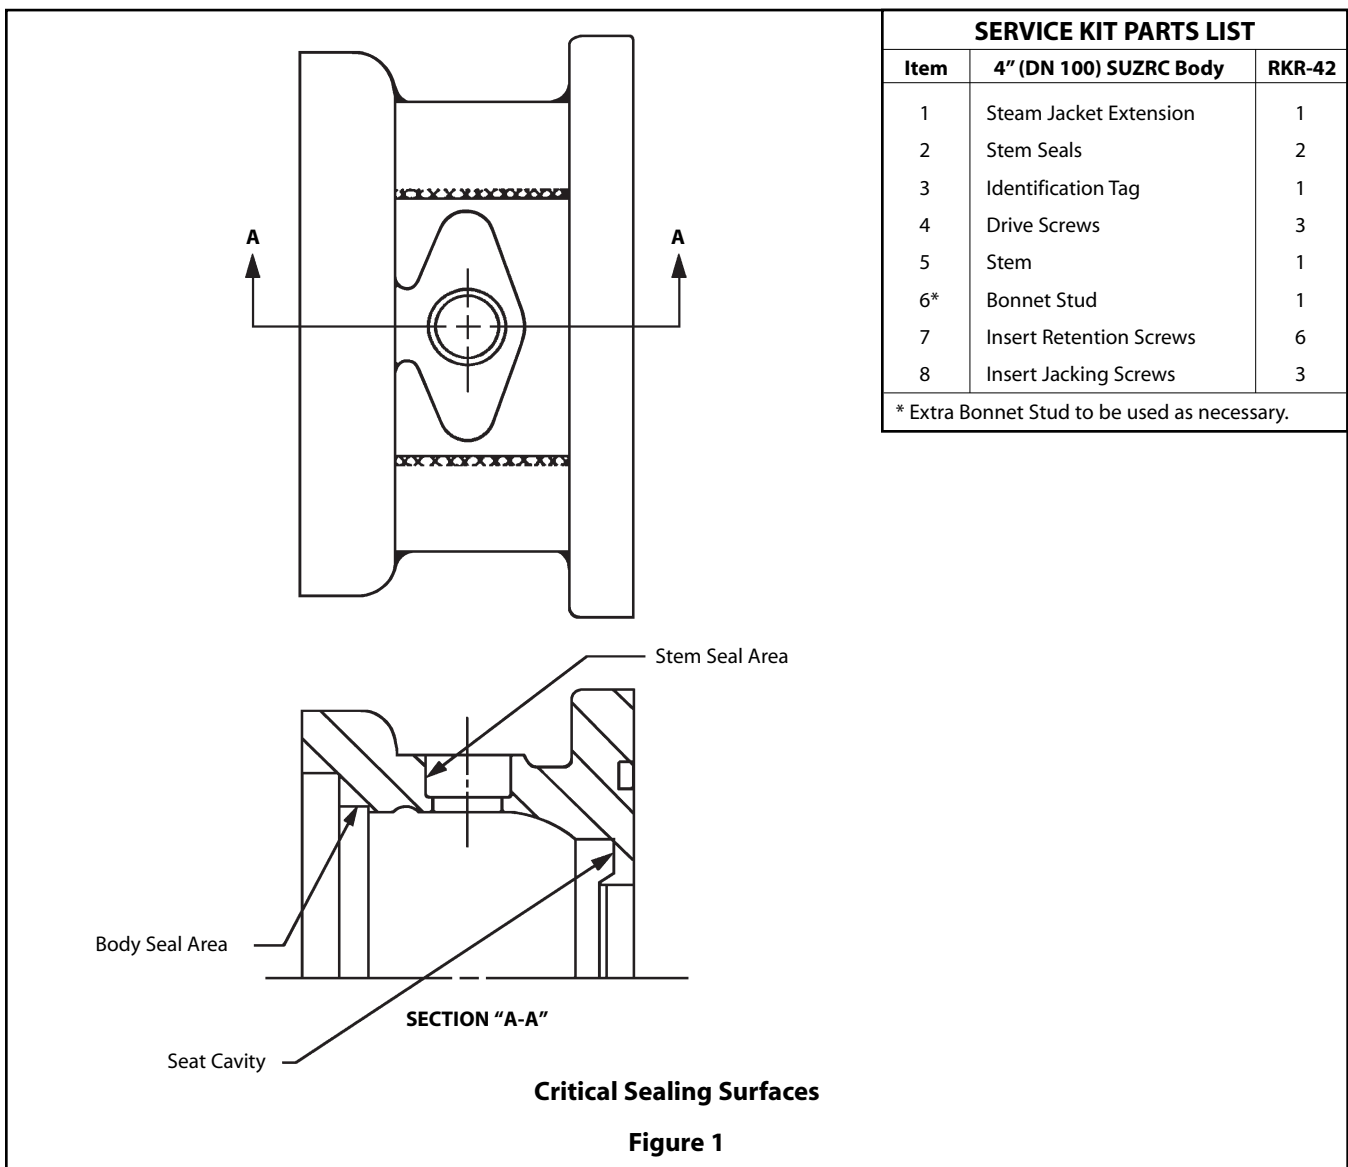
1. Thoroughly clean entire valve to bare metal without damaging critical sealing surfaces as noted in **(Figure 1)**. In order to provide sealing, the bare metal critical sealing surfaces must be free of gouges, nicks, grinding marks and other flaws that would prevent sealing.

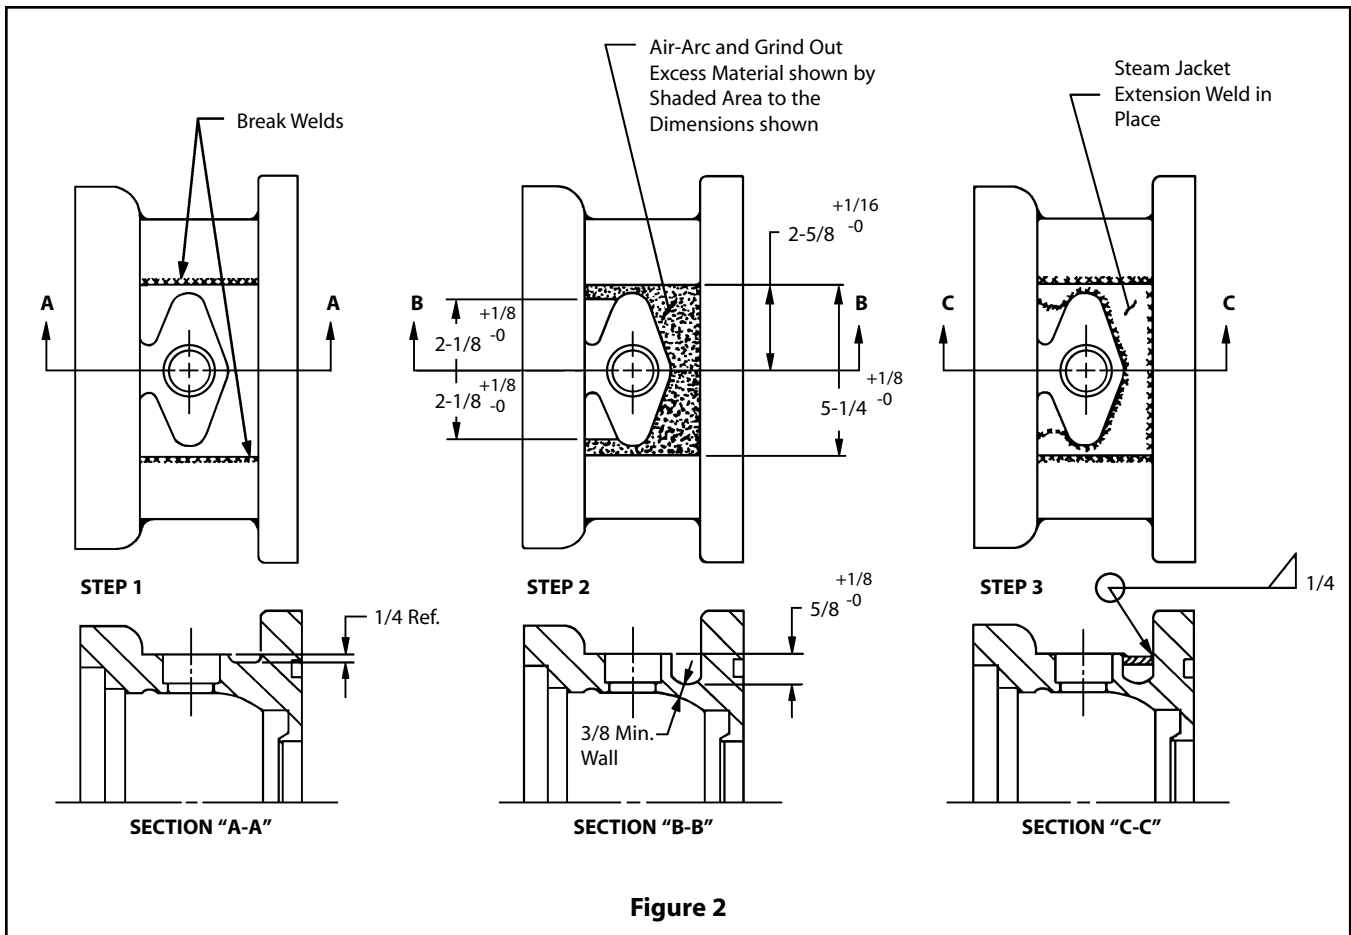
1. Break seam welds at the two places shown in Step 1, **(Figure 2)**.
2. Air-arc and grind out excess metal material shown by shaded area to the dimension shown in Step 2, **(Figure 2)**. Do not violate 3/8" (9.5 mm) minimum wall thickness as shown in **(Figure 2)**, Section B-B.

- Carefully fit steam jacket extension (1) around bonnet pad and butt to existing jacket as shown in **(Figure 2, Step 3)**.
- Weld per **(Figure 2, Step 3)**. Welding must be performed by welders qualified per ASME Section IX.

- Pneumatically pressure test the body for at least 3 minutes at 90 – 100 psi (6.2 – 6.9 bar). Immerse the entire body in water and observe for leakage. The criteria for this porosity test is zero leakage from the newly ground out area. The same criteria applies to the entire valve body. The old stem and bonnet hardware, together with new stem seals may be used for this porosity test.

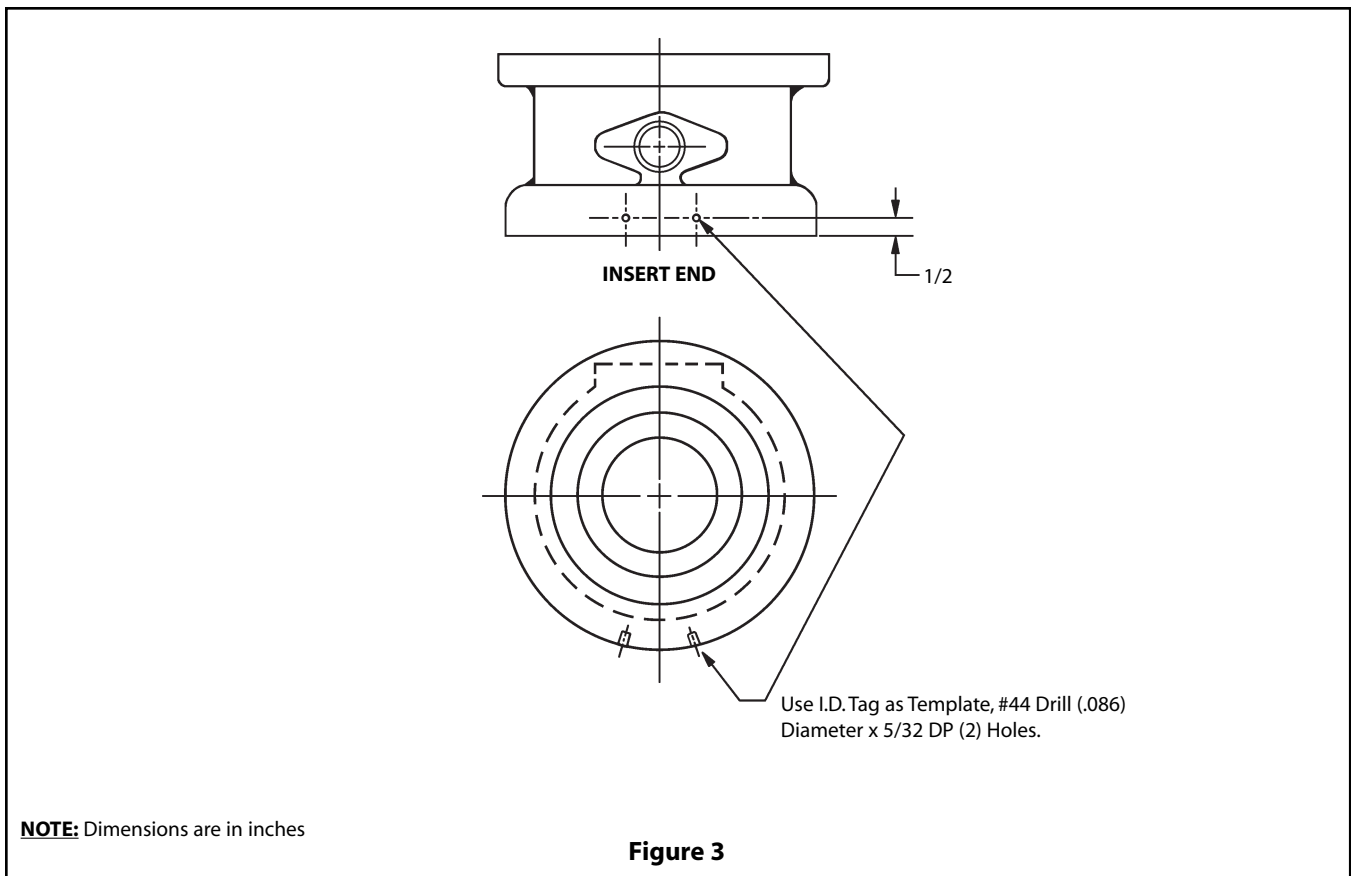
- Mount identification tag to insert flange by drilling as shown in **(Figure 3)** and driving in pins. One extra pin is provided.
- Failure to securely mount the tag will cause improper valve identification and will later result in incompatibility of repair kits.
